Sample Details	
Client Name:	Chief Engineer Example Client
Contact details:	Email: Test@abc123.com Mobile: 07XXXXXXX123
Date	20/06/2018
Analyst	Mr Cutler
Sampling point	Offline filter cart
Lab No.	1182224

Filter Tests

Objective of Analysis & Tests Performed

Filter submitted for analysis from a marine engine filtration system following a lube oil pump failure to determine the cause of failure. Client commented that engine had only recently been overhauled 3 weeks prior to failure and the lubricant was from a reputable supplier. An unused oil sample was provided from the IBC used to refill the system to establish if the oil in the filter was consistent with the oil in the machinery at time of failure.

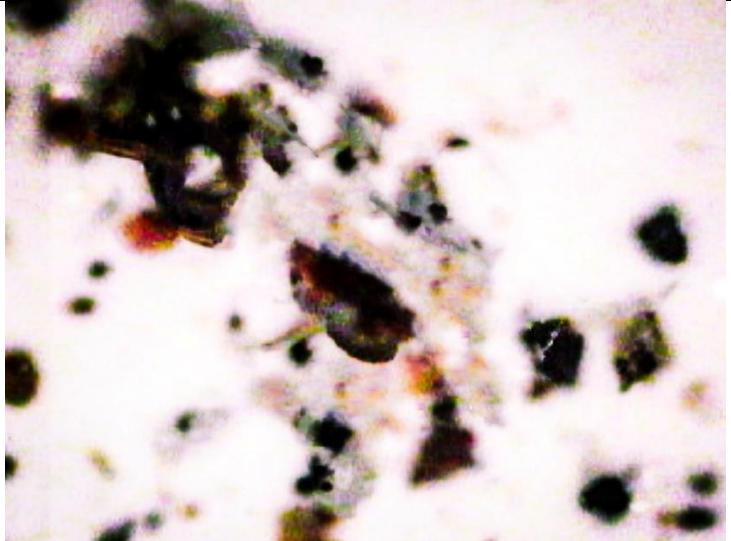
Each field view represents 1cm in size. The picture to the left shows significant ingress of sand particles, whilst the right picture shows a large long and curved cutting wear particle.

The particle composition shown on the left showed significant crystalline particles consistent with sand and the predominant wear type as cutting wear with sliding and fatigue particles. The elemental composition of the material was predominantly Silicon consistent with sand and copper, lead, tin and iron consistent with the pump material failure.

The findings show the failure mode has severe cutting wear, which is likely linked to the abrasive silicon based crystalline material observed. The Silicon source is most likely sand rather than cat fines or dirt because of the low Aluminium content detected. The Copper, Lead and Tin are consistent with bearing material and the iron is most likely additional material from the failure.

Advise to prevent failures such as this in future, inspect machine for sources of ingress such as storage tank breathers. Also review lubricant handling procedures from the point of transferring the lubricant from the IBC.

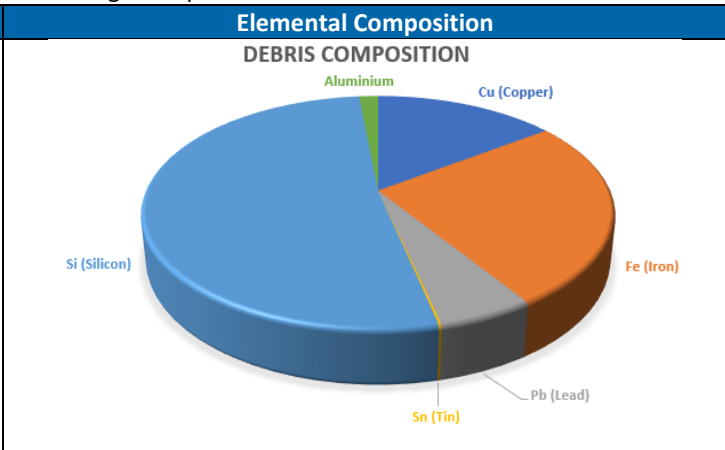
Particle Types	Frequency			
	Trace	Few	Moderate	Heavy
Corrosion	Trace			
Cutting Wear			Moderate	
Dark Metal Oxides	Trace			
Fatigue Chunks		Few		
Fibres	Trace			
Laminar Particles	Trace			
Non-ferrous (metallic)	Trace			
non-metallic (amorphous)		Few		
Non-metallic (crystalline)			Moderate	
Normal Rubbing	Trace			
Spheres	Trace			
Sliding Striated		Few

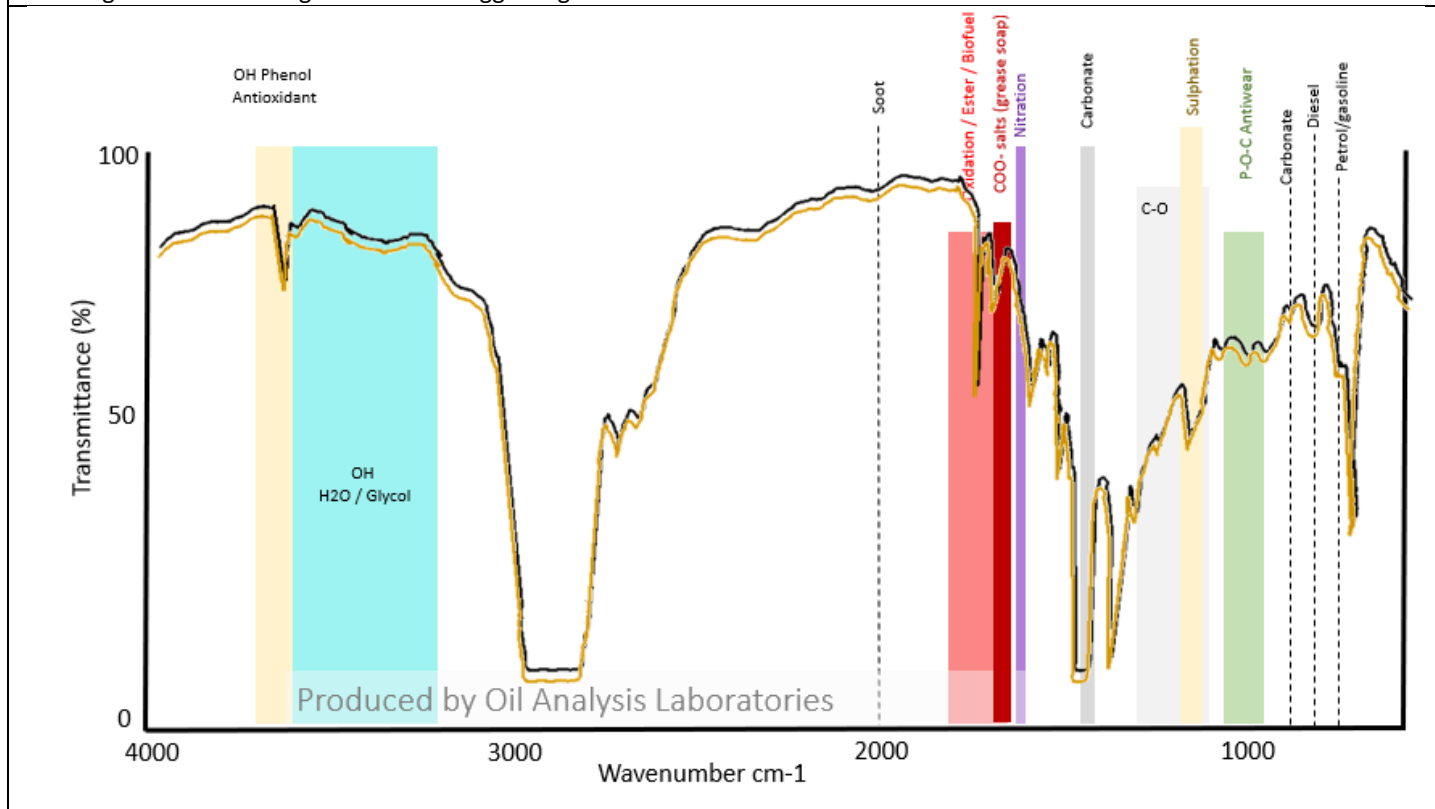
FTIR Findings

Comparison of new reference oil (yellow line) and used oil (black line) traces shows the two oils to be the same product. Both oils show significant remaining anti-oxidant suggesting the oil is in a near new condition.

The submitted reference oil for comparison shows by FTIR they are the same product, which suggests the clients fear the oil may not have been changed during the overhaul or the incorrect oil was used is unfounded. The IBC sample showed very little evidence of sand ingress, suggesting the contamination did not occur prior to arrival.
