# Filter Tests

Failure Investigations & Ferrographic Testing  
by Oil Analysis Laboratories

**Objective of Analysis & Tests Performed**

Filter submitted for analysis from a marine engine filtration system following a lube oil pump failure to determine the cause of failure. Client commented that engine had only recently been overhauled 3 weeks prior to failure and the lubricant was from a reputable supplier. An unused oil sample was provided from the IBC used to refill the system to establish if the oil in the filter was consistent with the oil in the machinery at time of failure.

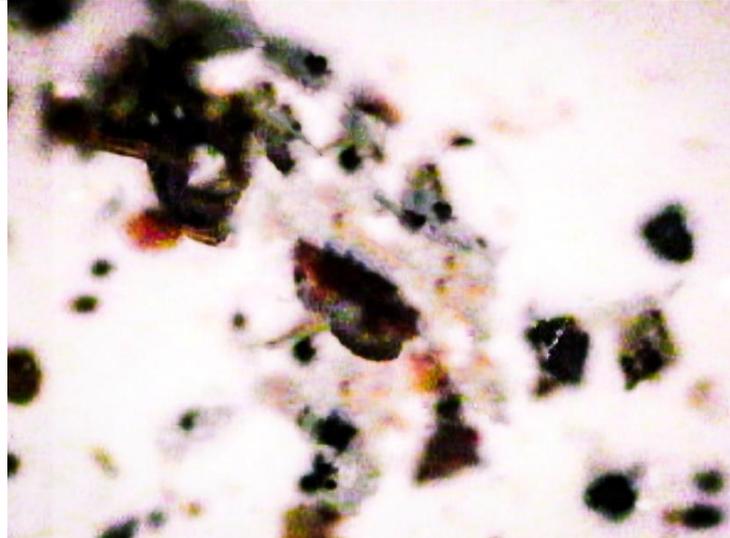
Each field view represents 1cm in size. The picture to the left shows significant ingress of sand particles, whilst the right picture shows a large long and curved cutting wear particle.

The findings show the failure mode has severe cutting wear, which is likely linked to the abrasive silicon based crystalline material observed. The Silicon source is most likely sand rather than cat fines or dirt because of the low Aluminium content detected. The Copper, Lead and Tin are consistent with bearing material and the iron is most likely additional material from the failure.

Advise to prevent failures such as this in future, inspect machine for sources of ingress such as storage tank breathers. Also review lubricant handling procedures from the point of transferring the lubricant from the IBC.

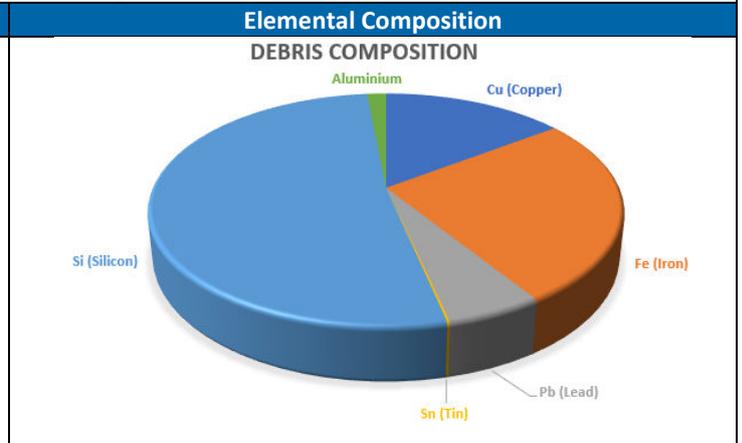
The particle composition shown on the left showed significant crystalline particles consistent with sand and the predominant wear type as cutting wear with sliding and fatigue particles. The elemental composition of the material was predominantly Silicon consistent with sand and copper, lead, tin and iron consistent with the pump material failure.

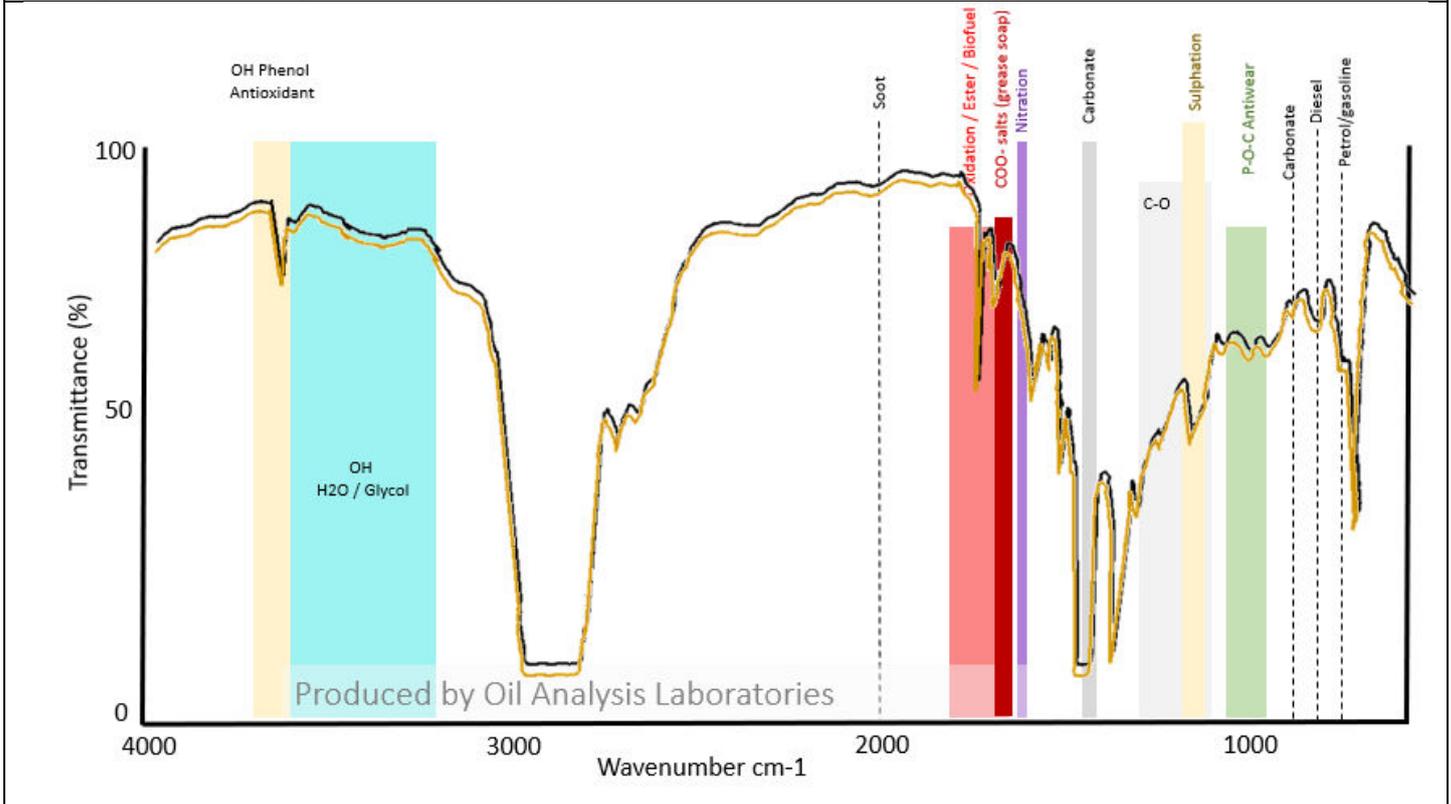
Comparison of new reference oil (yellow line) and used oil (black line) traces shows the two oils to be the same product. Both oils show significant remaining anti-oxidant suggesting the oil is in a near new condition.

The submitted reference oil for comparison shows by FTIR they are the same product, which suggests the clients fear the oil may not have been changed during the overhaul or the incorrect oil was used is unfounded. The IBC sample showed very little evidence of sand ingress, suggesting the contamination did not occur prior to arrival.
