Sample Details	
Client Name:	Chief Engineer Example Client
Contact details:	Email: Test@abc123.com Mobile: 07XXXXXXX123
Date	20/06/2018
Analyst	Mr Cutler
Sampling point	Offline filter cart
Lab No.	1182224

Filter Tests

Objective of Analysis & Tests Performed

Filter submitted for analysis from a marine engine filtration system following a lube oil pump failure to determine the cause of failure. Client commented that engine had only recently been overhauled 3 weeks prior to failure and the lubricant was from a reputable supplier. An unused oil sample was provided from the IBC used to refill the system to establish if the oil in the filter was consistent with the oil in the machinery at time of failure.

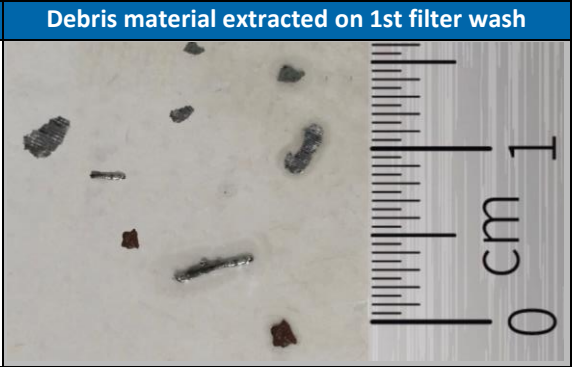
Analysis included a mixture of organic spectral chemistry, elemental analysis and wet chemistry techniques to determine the nature of the material and failure mode.
